New Hampshire Volunteer Lake Assessment Program

2003 Interim Report for Jenness Pond Northwood

NHDES Water Division Watershed Management Bureau 29 Hazen Drive Concord, NH 03301

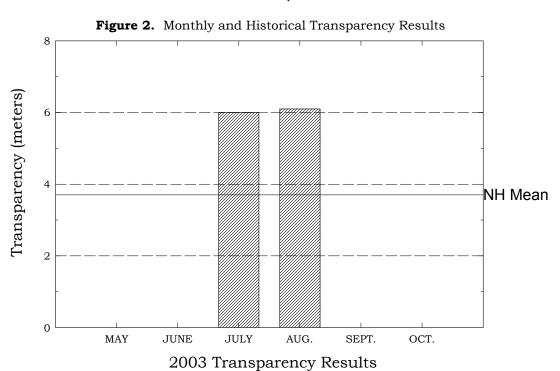
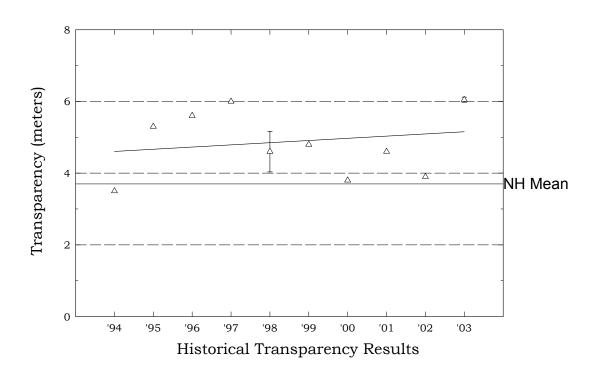
Figure 2 and Table 3: The graphs in Figure 2 (Appendix A) show historical and current year data for pond transparency. Table 3 (Appendix B) lists the maximum, minimum and mean transparency

The current year data (the top graph) show that the in-lake transparency **remained stable** from July to August. The transparency on both sampling events was **greater than** the state mean. (Please note that a Secchi disk reading was not taken on the June sampling event.)

Overall, visual inspection of the historical data (the bottom graph) shows **a variable** trend for in-lake transparency, meaning that the transparency has **fluctuated** since monitoring began. As discussed previously, in the 2004 annual report, we will conduct a statistical analysis of the historical data to objectively determine if there has been a significant change in the annual mean transparency since monitoring began.

Typically, high intensity rainfall causes erosion of sediments into lakes/ponds and streams, thus decreasing clarity. Efforts should continually be made to stabilize stream banks, pond shorelines, disturbed soils within the watershed, and especially dirt roads located immediately adjacent to the edge of tributaries and the pond. Guides to Best Management Practices designed to reduce, and possibly even eliminate, nonpoint source pollutants, such as sediment loading, are available from DES upon request.

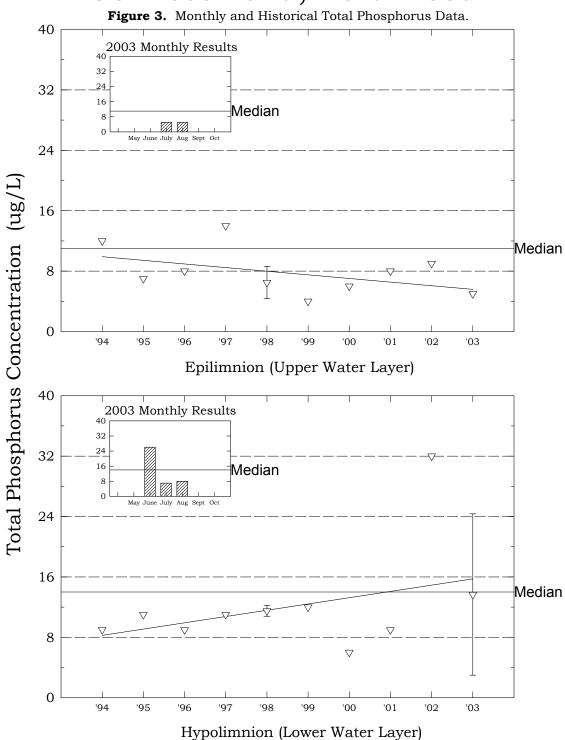
Figure 3 and Table 8: The graphs in Figure 3 (Appendix A) show the amounts of phosphorus in the epilimnion (the upper layer) and the hypolimnion (the lower layer); the inset graphs show current year data. Table 8 (Appendix B) lists the annual maximum, minimum, and median concentration for each deep spot layer and each tributary since the pond has joined the program.

The current year data for the epilimnion (the top inset graph) show that the phosphorus concentration **remained stable** from July to August. The phosphorus concentration on both sampling events was **less than** the state median. (Please note that an epilimnion sample was not submitted to the laboratory on the June sampling event.)

The current year data for the hypolimnion (the bottom inset graph) show that the phosphorus concentration **decreased greatly** from June to July, and then **increased very slightly** from July to August. The phosphorus concentration in June was **much greater than** the state median, while the concentration in July and August was **less than** the state median.

Overall, visual inspection of the historical data trend line for the epilimnion shows a *variable* total phosphorus trend, which means that the concentration has *fluctuated* in the epilimnion since monitoring began in 1994.

Overall, visual inspection of the historical data trend line for the hypolimnion shows *an increasing* total phosphorus trend, which means that the concentration has *worsened* in the hypolimnion since monitoring began. (Note: This increase is due to the high concentration that was observed in the hypolimnion during the 2002 season.)

One of the most important approaches to reducing phosphorus loading to a waterbody is to continually educate watershed residents about its sources and how excessive amounts can adversely impact the ecology and value of lakes and ponds. Phosphorus sources within a lake or pond's watershed typically include septic systems, animal waste, lawn fertilizer, road and construction erosion, and natural wetlands.
